# Energy Efficient Retrofit Assessment

Newark Town Hall

Project:Energy Efficiency Retrofit Assessment - Newark Town Hall

This document has been prepared by: Guy Taylor Associates | Job no: 34.531.17 | Date: September 2024 | Status: Initial Analysis | Rev: -

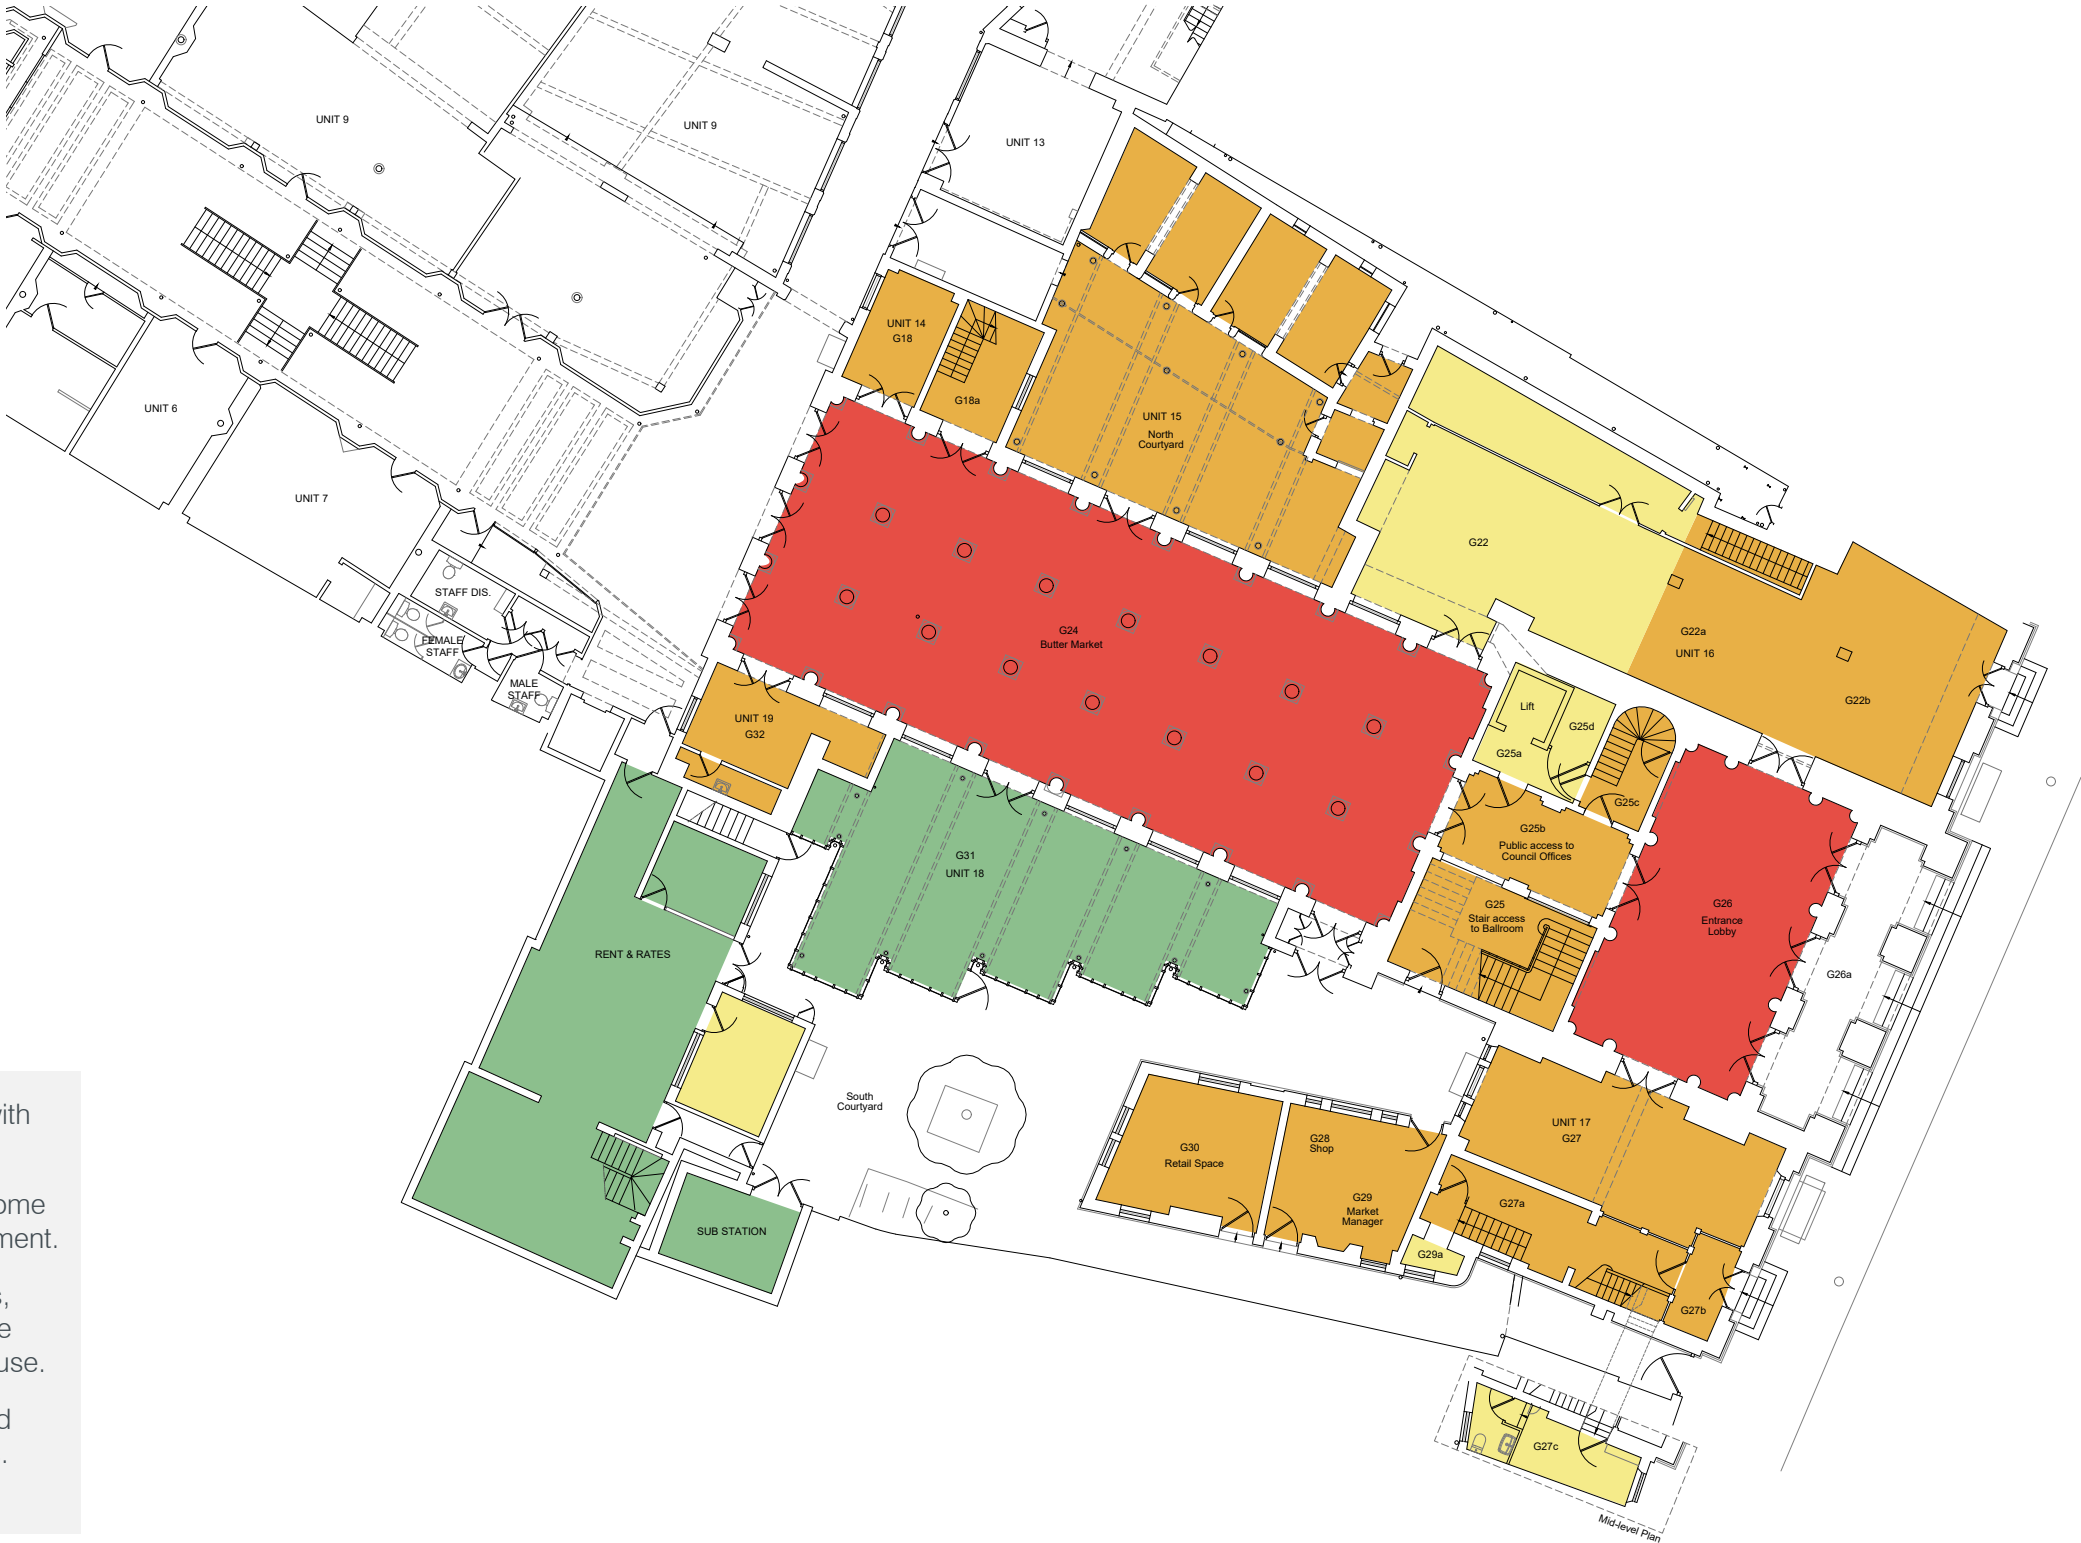
GROUND FLOOR PLAN

- Original room of primary quality with little or no scope for change.
- Substantially original room with some adaptations and scope for betterment.
- Secondary room with adaptations, scope for betterment and possible further adaptation to secure new use.
- Tertiary room with adaptations and with scope for further adaptations.

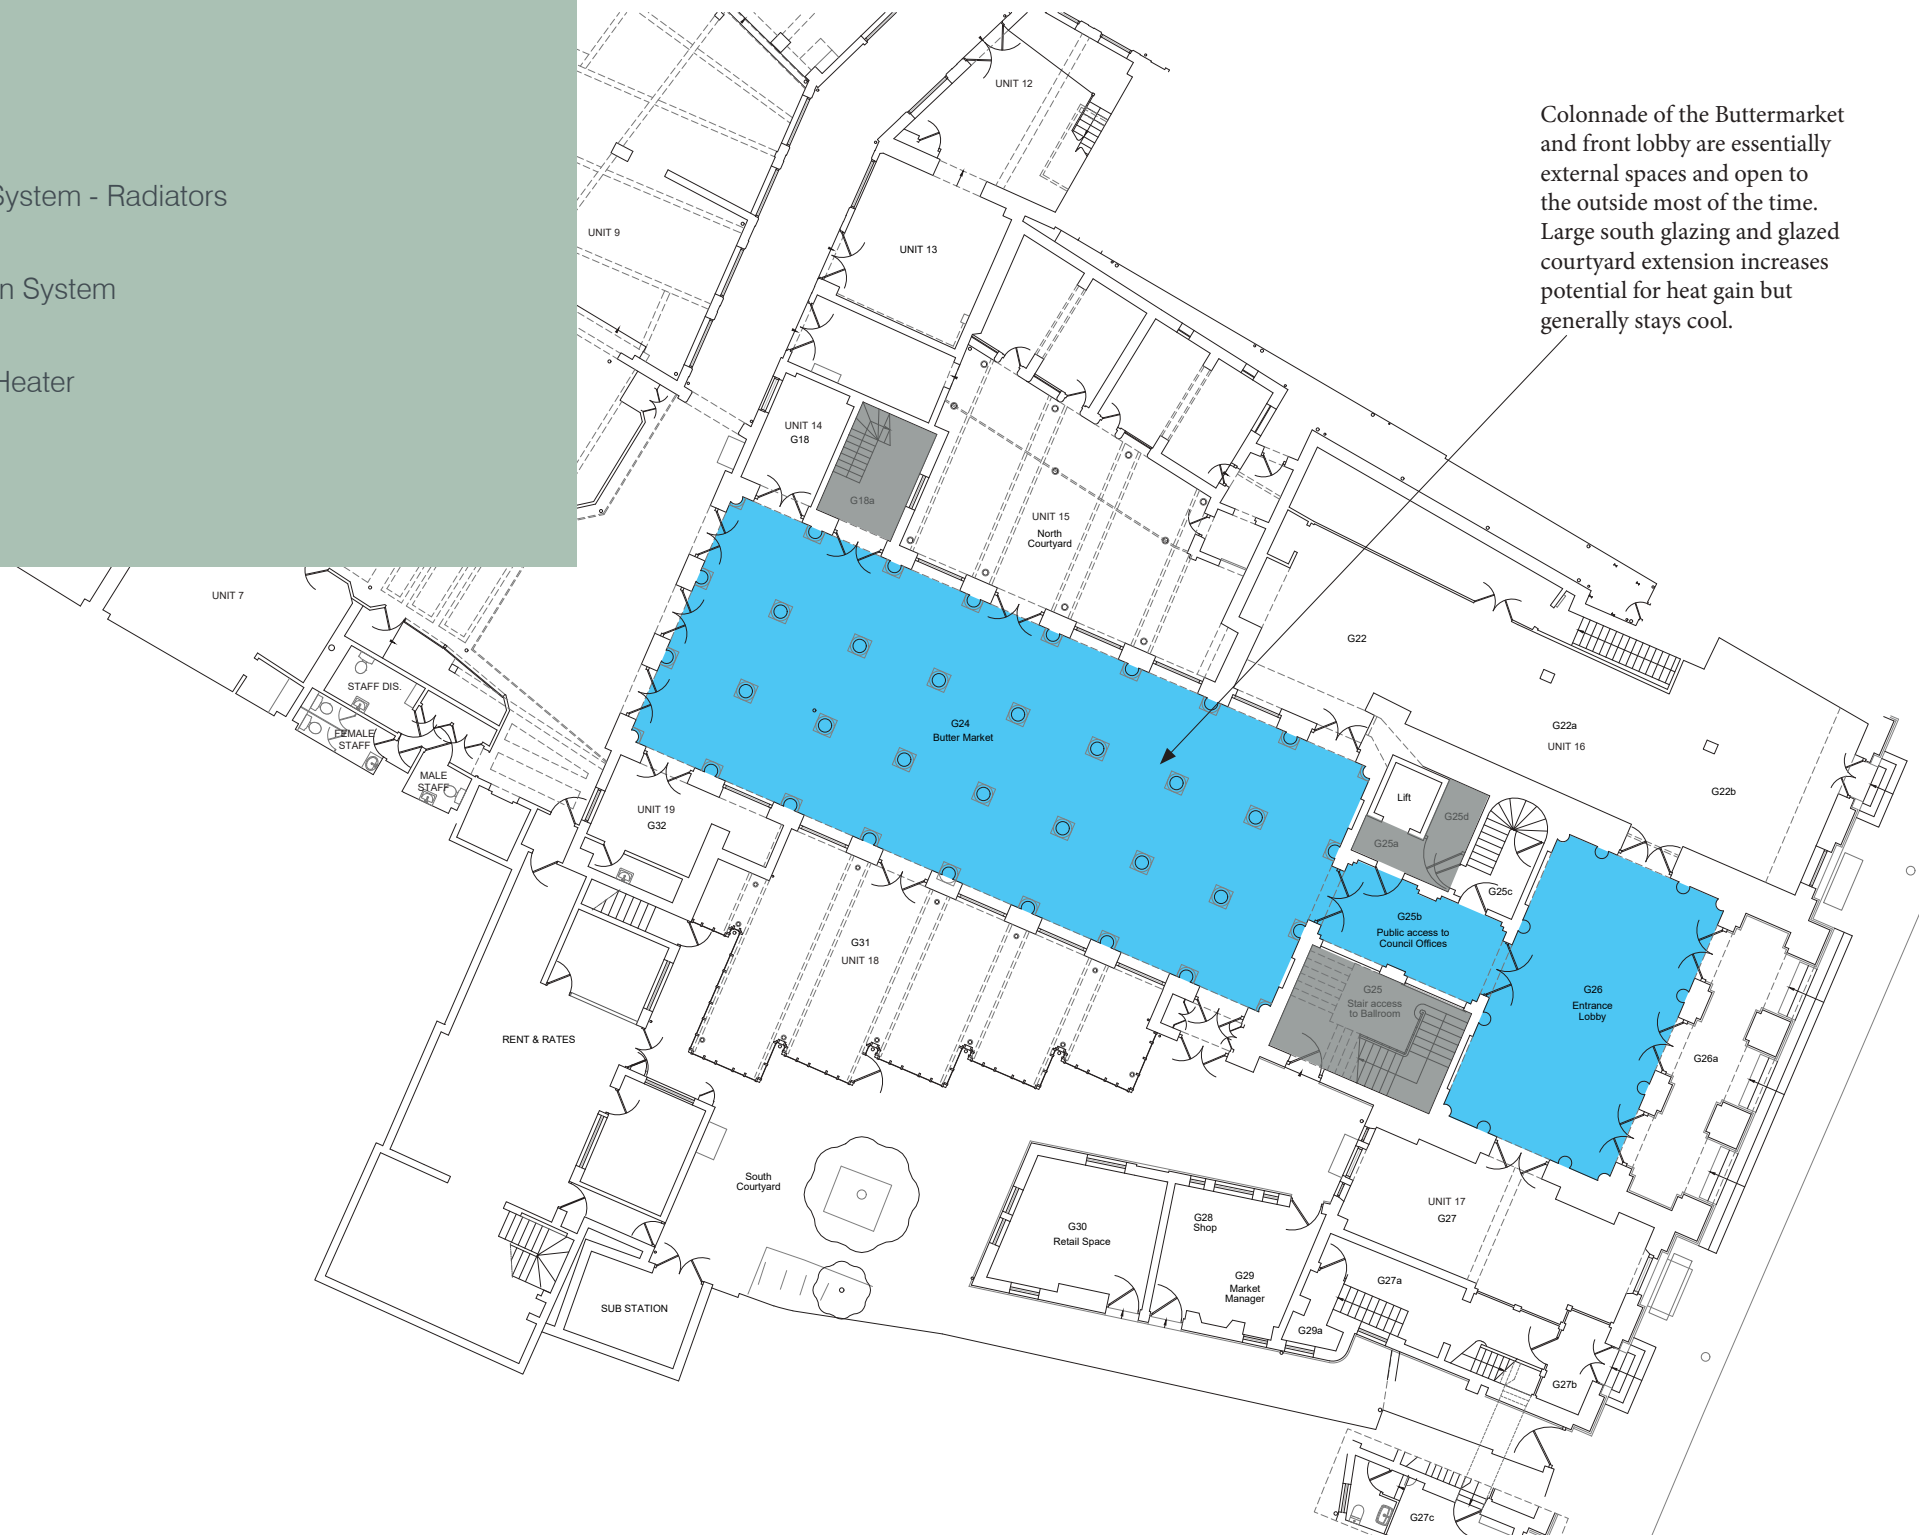
## Ground Floor

Colonnade of the Buttermarket and front lobby are essentially external spaces and open to the outside most of the time. Large south glazing and glazed courtyard extension increases potential for heat gain but generally stays cool.

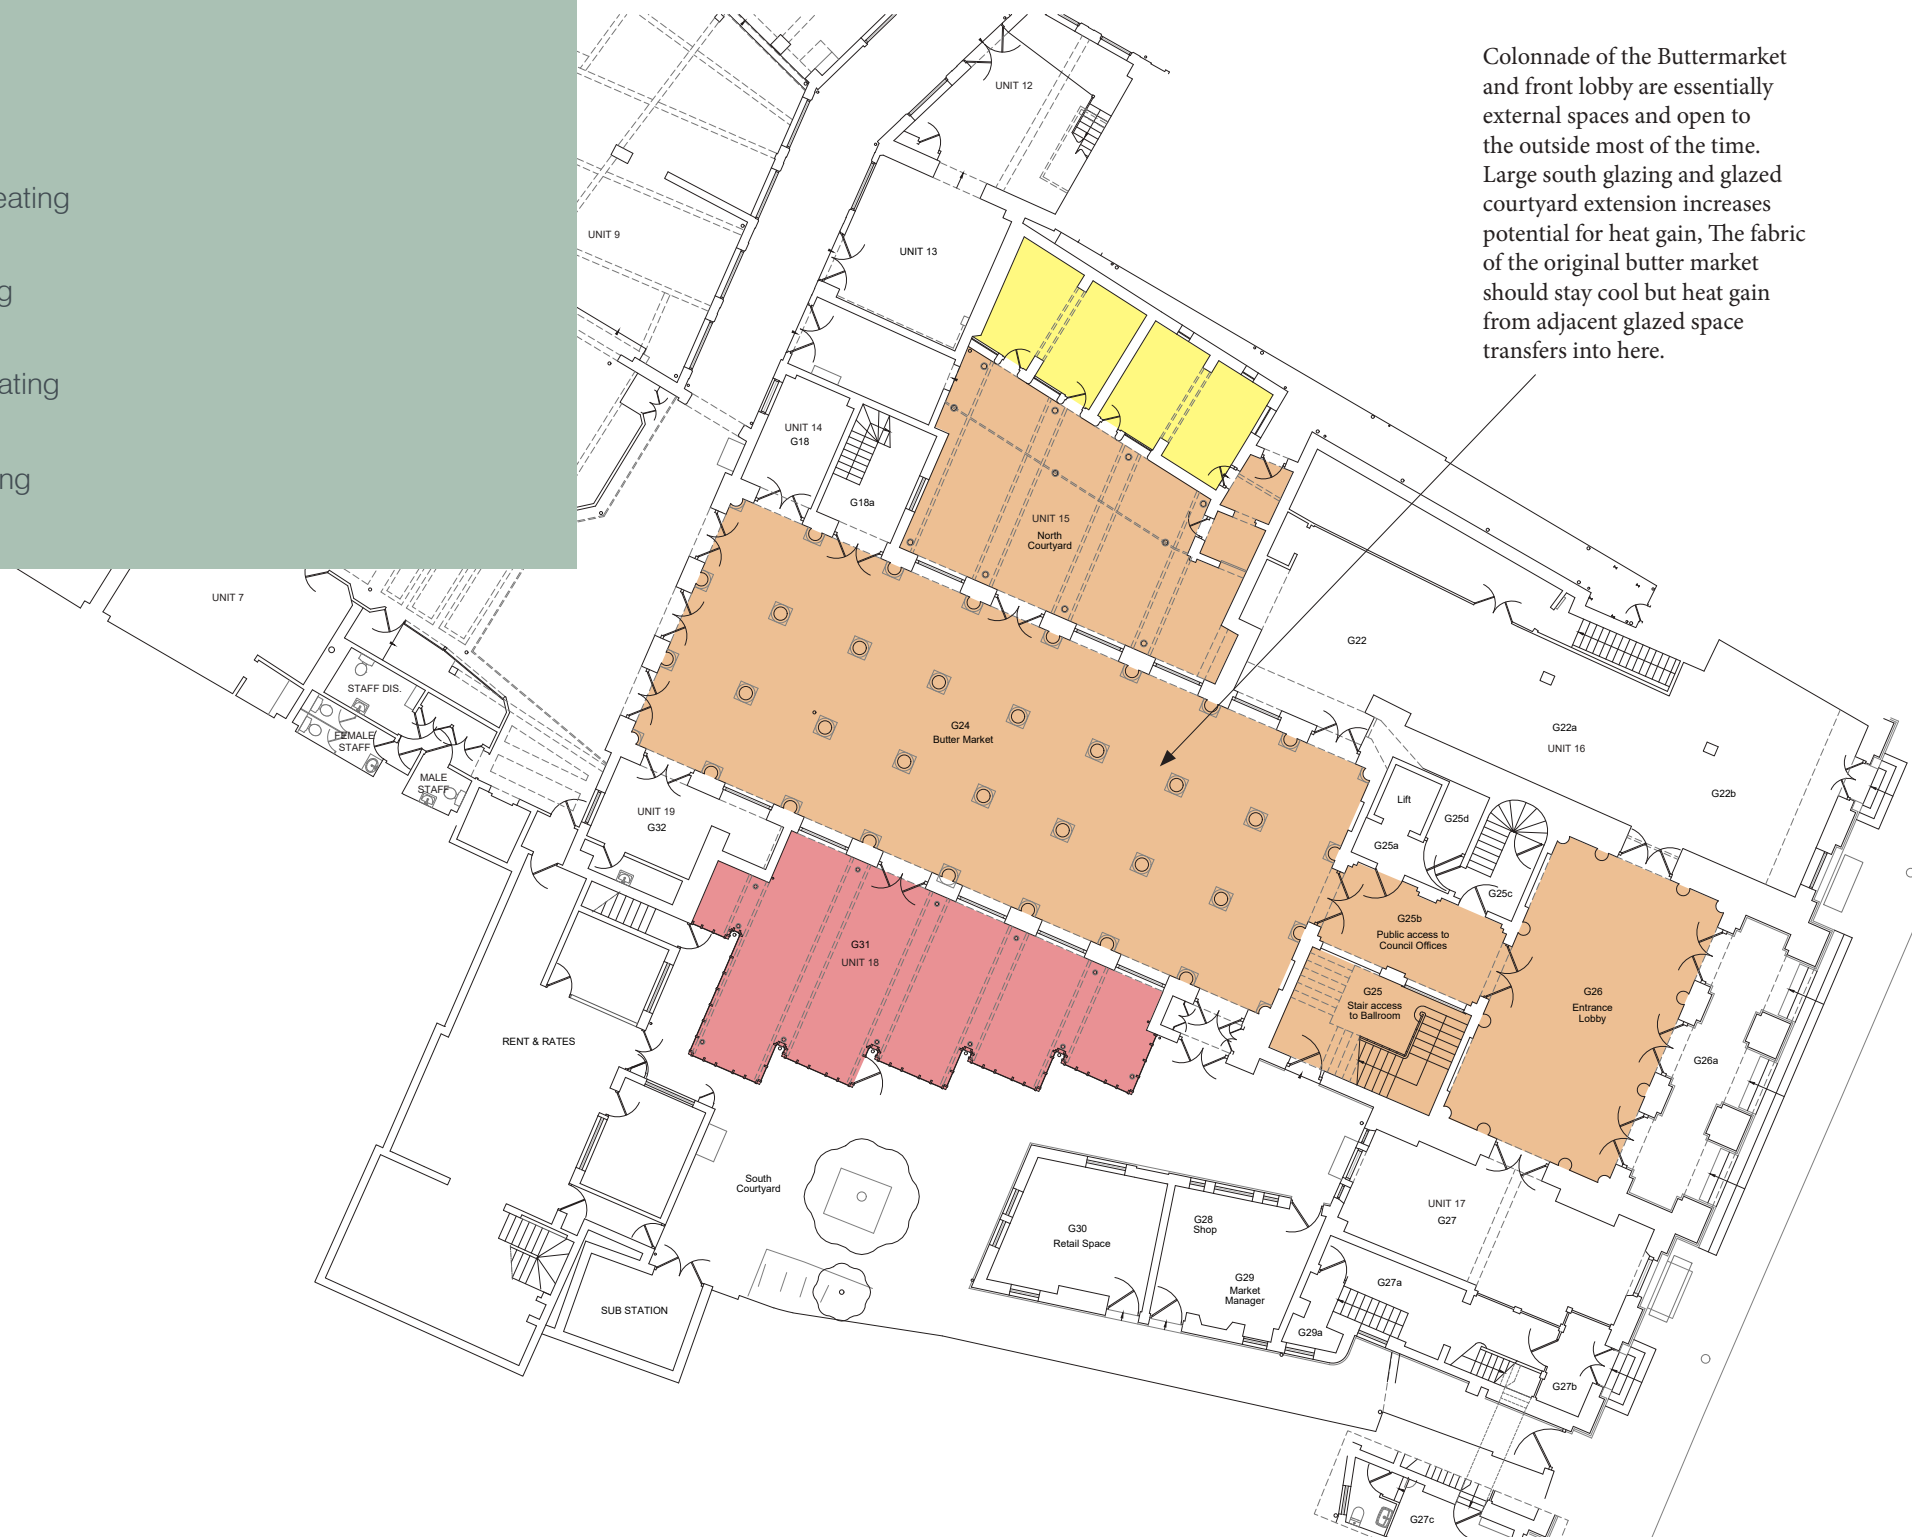
## Ground Floor

Colonnade of the Buttermarket and front lobby are essentially external spaces and open to the outside most of the time. Large south glazing and glazed courtyard extension increases potential for heat gain, The fabric of the original butter market should stay cool but heat gain from adjacent glazed space transfers into here.

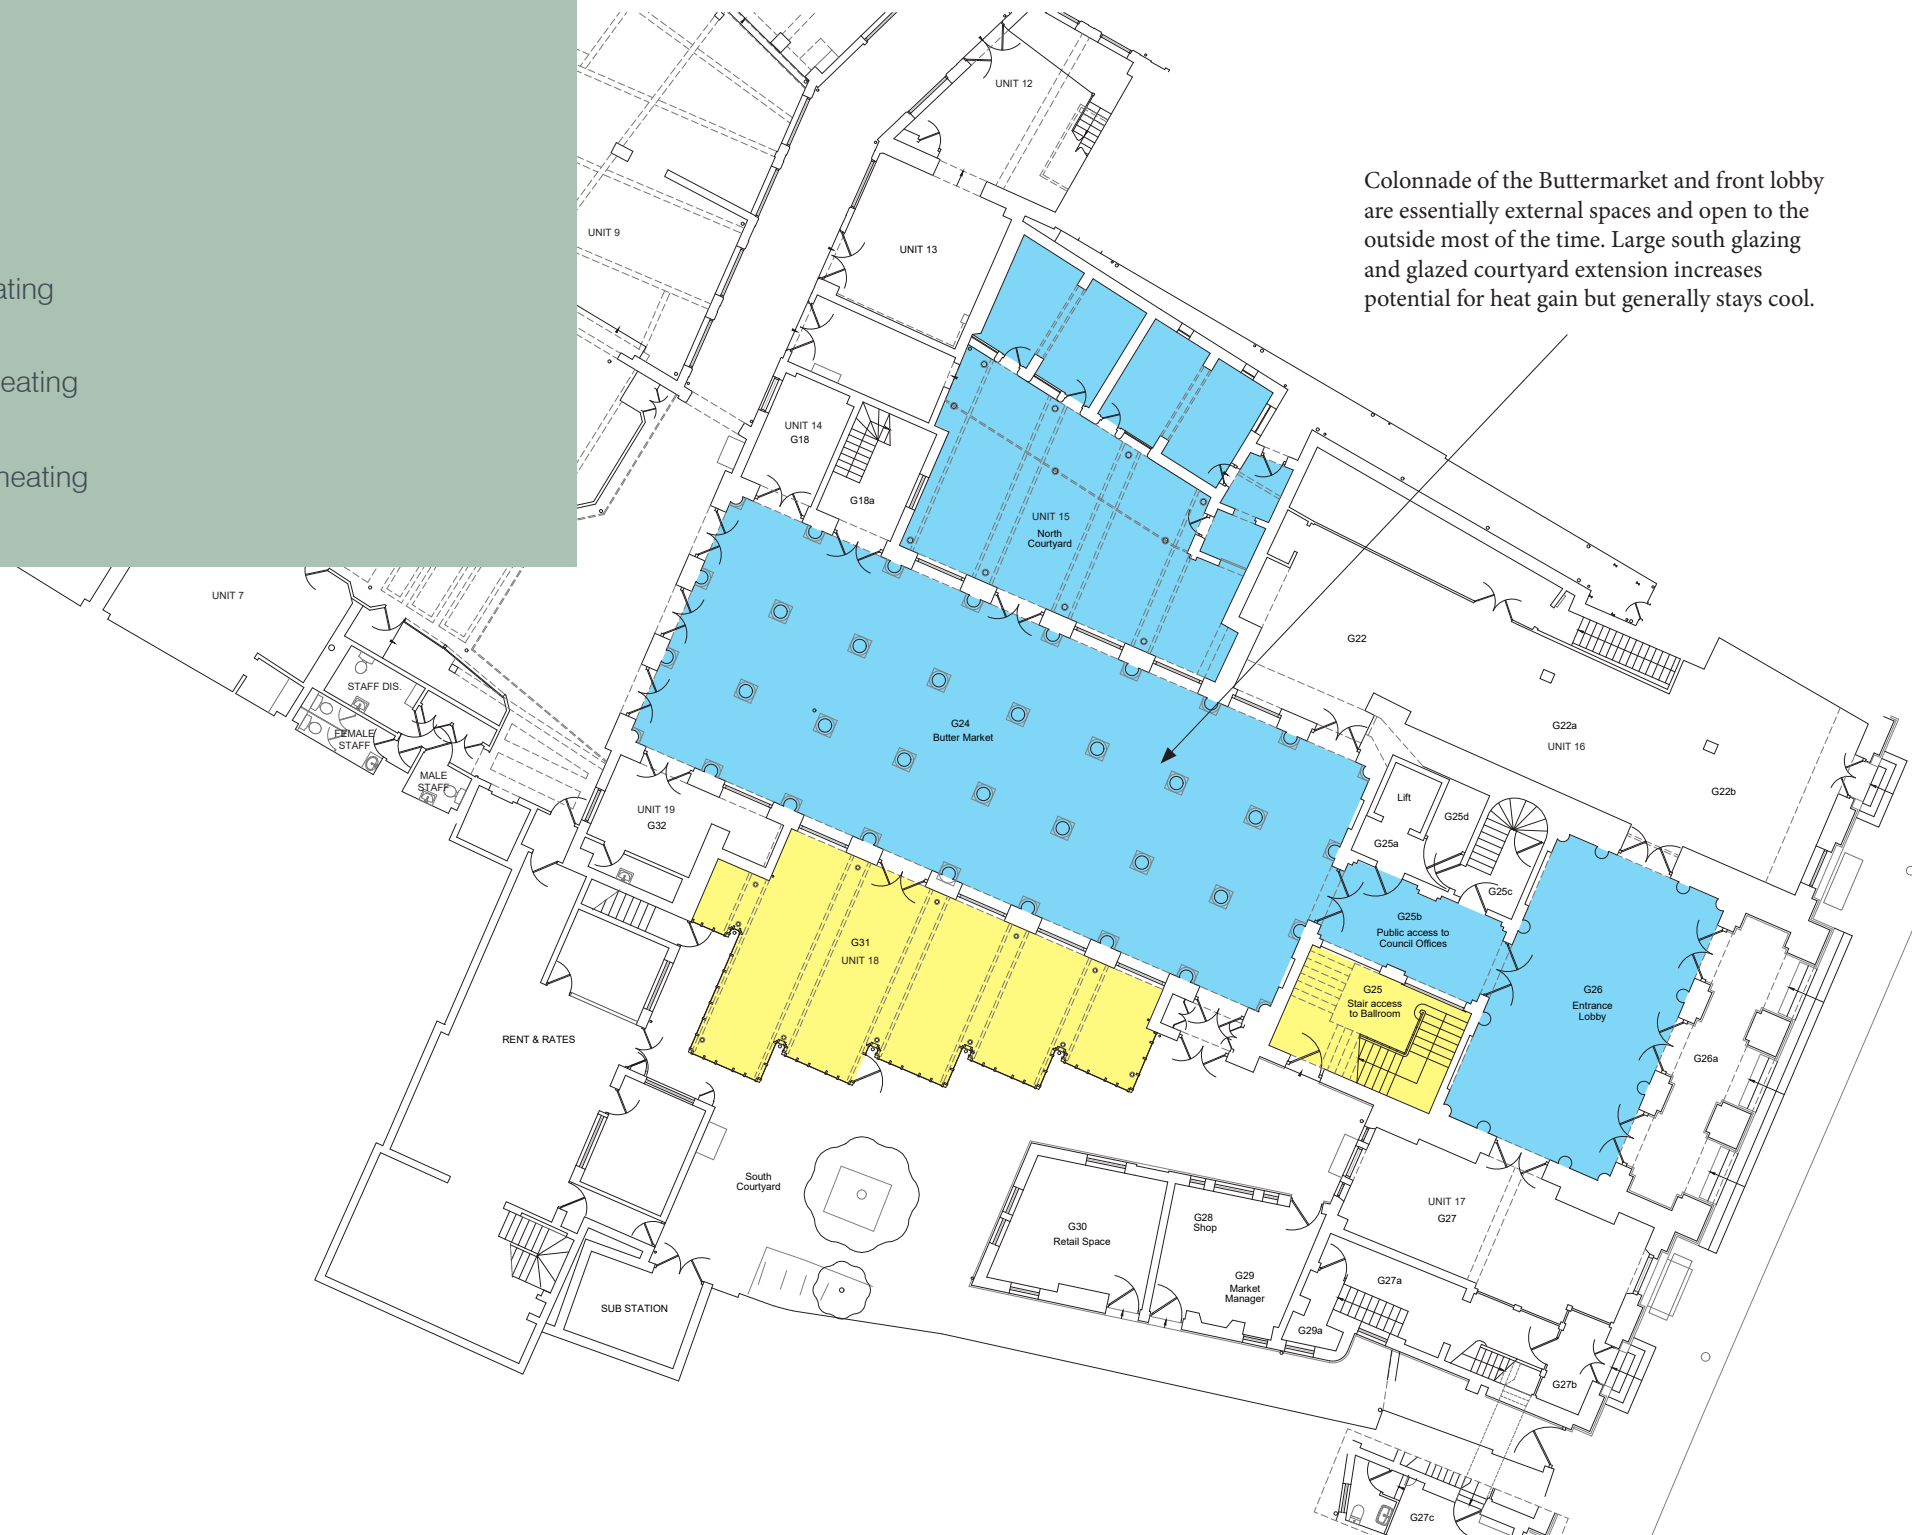
# Ground Floor

Colonnade of the Buttermarket and front lobby are essentially external spaces and open to the outside most of the time. Large south glazing and glazed courtyard extension increases potential for heat gain but generally stays cool.
